WELDING INSPECTION REPORT

Resident Engineer: Casey, William **Report No:** WIR-027513 Address: 333 Burma Road **Date Inspected:** 28-Apr-2012

OSM Arrival Time: 700 **Project Name:** SAS Superstructure Prime Contractor: American Bridge/Fluor Enterprises, a JV **OSM Departure Time:** 1530 Contractor: American Bridge/Fluor Enterprises, a JV **Location:** Job Site

34-0006 **Bridge No: Component: SAS** Tower

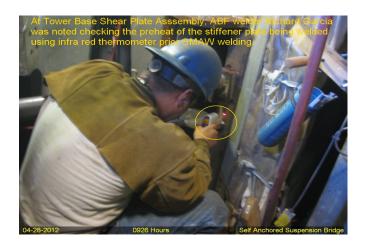
At Tower Base bearing plate, ABF welder Richard Garcia was observed continuing to perform 3G (vertical position) Shielded Metal Arc Welding (SMAW) welding fill pass to fill pass on 60mm thick stiffener plate shop marked P157 and weld joint #W008. The welder was noted using SMAW with 3.2mm diameter E7018H4R electrode on the fill pass. The 60mm thick stiffener has a 45 degree single bevel configured for a Partial Joint Penetration (PJP). The stiffener plate is being PJP welded to the 60 mm bearing plate. Prior welding, the welded root pass was tested using Magnetic Particle Testing (MT) by ABF QC Bernie Docena and noted no relevant indication during the test. This QA performed same MT verification and noted same result. The welder resumed 3G groove welding until the end of the shift without completing the joint. The plates were preheated to more than 150°F using propylene gas torch. This QA Inspector observed QC Inspector Bernie Docena using a Fluke infra red temperature gauge to verify the preheat temperature of more than 150°F. This QA Inspector performed a verification of the welding parameters and observed 130 amperes on 3.2mm E7018H4R electrode.
